Access Compliance Report Public Rights-of-Way (Curb Ramps)

Main Street: CARLISLE_CT **Cross Street:** LANGFORD_RD **Location:** S

ADA ID: RPRK211111115523 **Ramp Type:** Type 4 - Parallel **Initial Pass/Fail:** Fail **Overall Compliance:** No **Severity Score:** 30

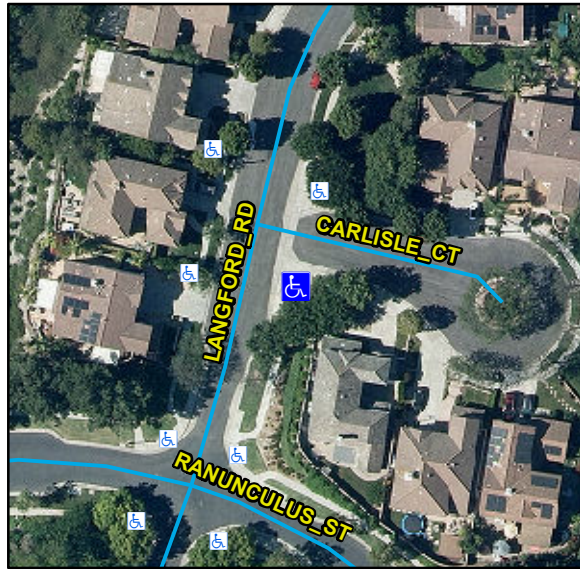
Compliance	Description	Data	Compliance	Description	Data
N/A	Ramp Length LT (in)	142	N/A	Ramp Length RT (in)	142
Yes	Ramp Width LT (in)	54	Yes	Ramp Width RT (in)	54
No	Ramp Run Slope LT (%)	18.4	Yes	Ramp Run Slope RT (%)	2.8
Yes	Ramp Cross Slope LT (%)	1	Yes	Ramp Cross Slope RT (%)	0.1
N/A	Landing Present	N/A	N/A	DWS Provided	N/A
N/A	Landing Length (in)	N/A	N/A	DWS Contrast	N/A
N/A	Landing Width (in)	N/A	N/A	DWS Length (in)	N/A
N/A	Landing Run Slope (%)	N/A	N/A	DWS Full Width	N/A
N/A	Landing Cross Slope (%)	N/A		DWS Offset Type	N/A
N/A	Landing Movement Obstructed?	N/A	N/A	DWS Offset Left (in)	N/A
	Landing Movement Type	N/A	N/A	DWS Offset Right (in)	N/A
N/A	Landing Shared	N/A			
N/A	Clear Space	Yes			
N/A	Clear Space To Crosswalk (in)	N/A			
N/A	Marked Crosswalk 1	No	N/A	Marked Crosswalk 2	No
	Crossing 1 Direction	NE		Crossing 2 Direction	NW
N/A	Marked Crosswalk 1 Width (in)	N/A		Marked Crosswalk 2 Width (in)	N/A

Possible Solutions:
Remove & Replace Curb Ramp With Two New Directional Ramps or Equivalent.
