# Access Compliance Report Public Rights-of-Way (Curb Ramps)

Main Street: O\_NEILL\_DR Cross Street: SIENNA\_PKWY Location: SE

ADA ID: RPRK211111125259 Ramp Type: Type 1 - Perpendicular Initial Pass/Fail: Pass Overall Compliance: No Severity Score: 0

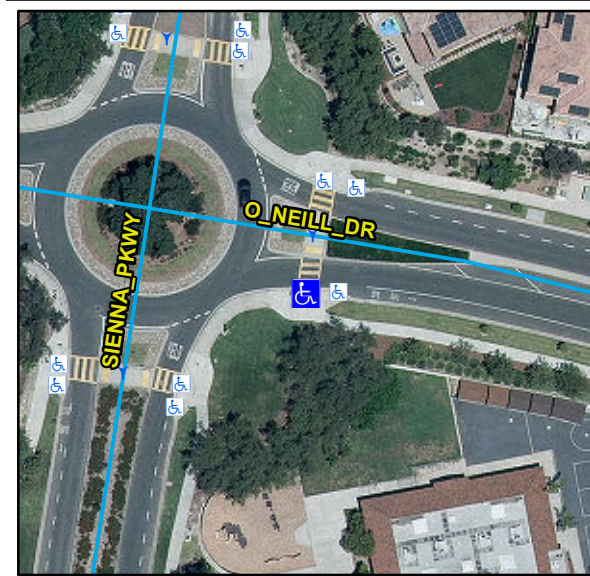
| Compliance | Description | Data | Compliance | Description | Data |
|---|---|---|---|---|---|
| N/A | Ramp Length (in) | 85 | No | Flare Type LT | Curbed1 |
| Yes | Gutter Ponding | No | No | Curb Slope | 6.1 |

Possible Solutions:  
**Remove & Replace Entire Ramp.**

OC Std/PROW:  
**R304.2.2, R304.2.3, STD 1115**

Total Cost: \$ 3080
