# Access Compliance Report Public Rights-of-Way (Curb Ramps)

| Main Street: S_SELLAS_RD | | Cross Street: SIENNA_PKWY | | Location: | SE |
| ADA ID: RPRK211111134109 | Ramp Type: Type 1 - Perpendicular | Initial Pass/Fail: Fail | Overall Compliance: No | Severity Score: | 15 |

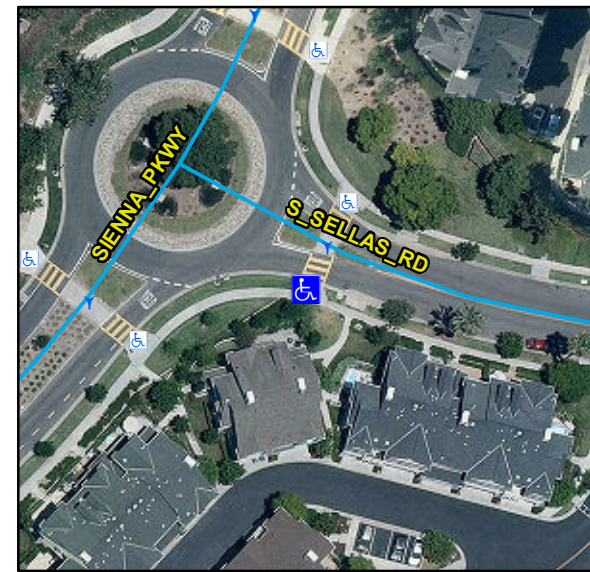
R304.2.2, R204.3, STD 1115

| Compliance | Description | Data | Compliance | Description | Data |
|---|---|---|---|---|---|
| No | Ramp Run Slope (%) | 11.8 | N/A | Flare Slope LT (%) | N/A |

Remove & Replace Entire Ramp.
