# Access Compliance Report Public Rights-of-Way (Curb Ramps)

Main Street: S\_DAISSY\_ST Cross Street: GILLY\_FLOWER\_ST Location: SE

ADA ID: RPRK211111141622 Ramp Type: Type 4 - Parallel Initial Pass/Fail: Fail Overall Compliance: No Severity Score: 2

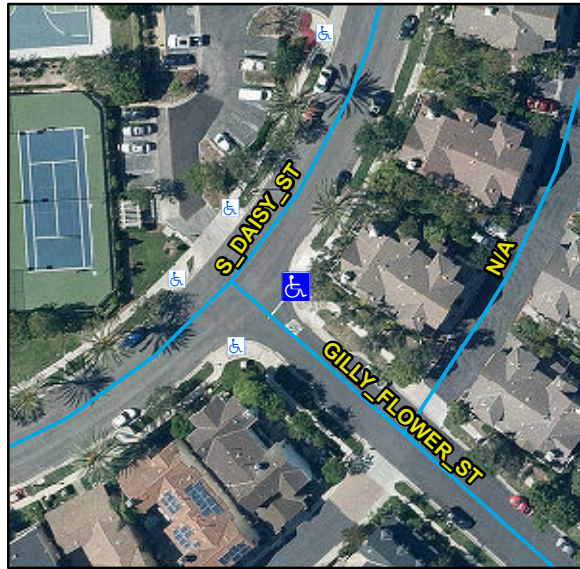
| Compliance | Description | Data | Compliance | Description | Data |
|---|---|---|---|---|---|
| No | Ramp Cross Slope LT (%) | 3.2 | No | Ramp Cross Slope RT (%) | 4.5 |

**Remove & Replace Curb Ramp With Two New Directional Ramps or Equivalent.**
