# Access Compliance Report Public Rights-of-Way (Curb Ramps)

| Main Street: SIENNA_PKWY | | Cross Street: S_DAISSY_ST | | Location: | NW |
| ADA ID: RPRK211112115227 | Ramp Type:Type 1 - Perpendicular | Initial Pass/Fail: Fail | Overall Compliance: No | Severity Score: | 30 |

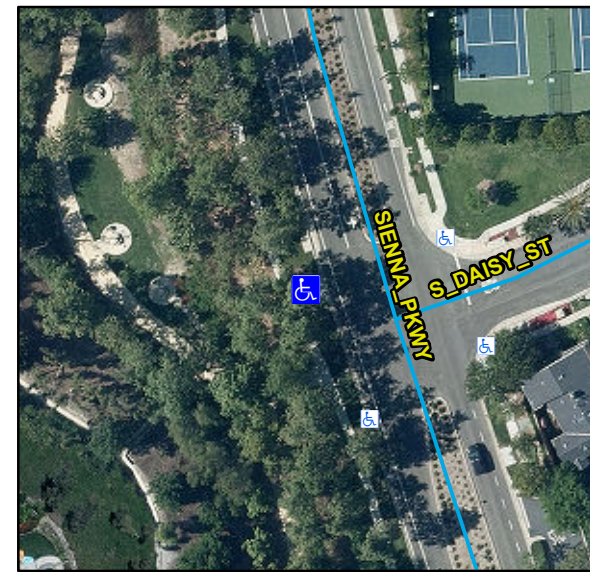
**R304.2.2, R204.3, STD 1115**

| Compliance | Description | Data | Compliance | Description | Data |
|---|---|---|---|---|---|
| No | Ramp Run Slope (%) | 12.1 | N/A | Flare Slope LT (%) | N/A |

**Remove & Replace Entire Ramp.**
