# Access Compliance Report Public Rights-of-Way (Curb Ramps)

Main Street: ANTONIO\_PKWY Cross Street: CORPORATE\_DR Location: NE

ADA ID: RPRK211115165900 Ramp Type: Type 1 - Perpendicular Diagonal Initial Pass/Fail: Fail Overall Compliance: No Severity Score: 15

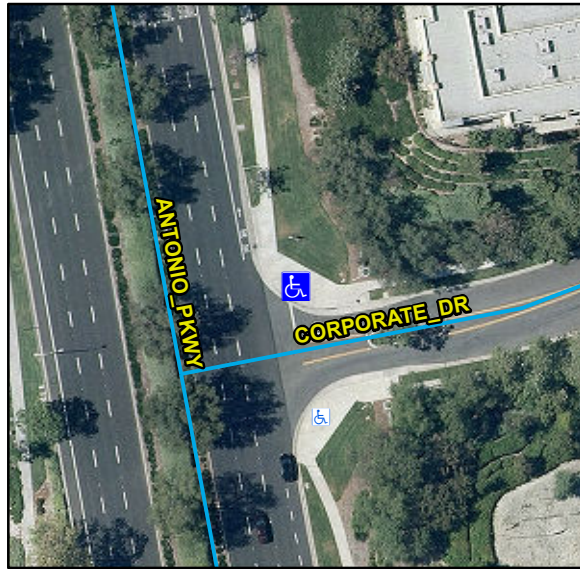
R304.2.2, R204.3, STD 1115

| Compliance | Description | Data | Compliance | Description | Data |
|---|---|---|---|---|---|
| No | Ramp Run Slope (%) | 8.5 | N/A | Flare Slope LT (%) | N/A |

Remove & Replace Curb Ramp With Two New Directional Ramps or Equivalent.
