# Access Compliance Report Public Rights-of-Way (Curb Ramps)

Main Street: NACIENTE\_ST Cross Street: SENDERO\_WAY Location: SW

ADA ID: RPRK211117125151 Ramp Type: Type 4 - Parallel Initial Pass/Fail: Fail Overall Compliance: No Severity Score: 16

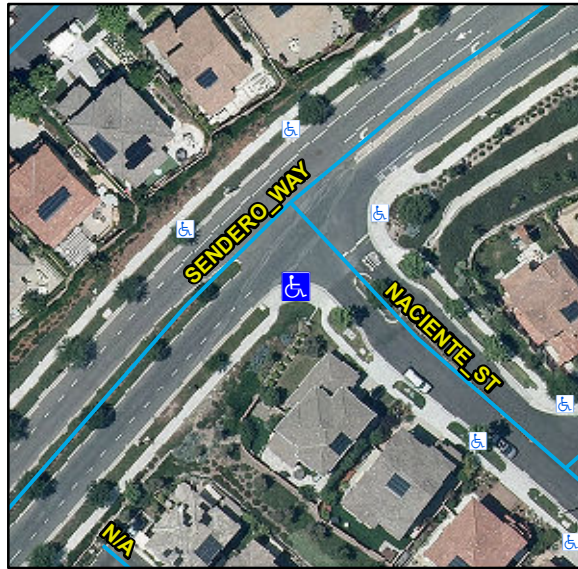
| Compliance | Description | Data | Compliance | Description | Data |
|---|---|---|---|---|---|
| No | Ramp Run Slope LT (%) | 8.8 | No | Ramp Run Slope RT (%) | 9 |
| No | Ramp Cross Slope LT (%) | 2.5 | Yes | Ramp Cross Slope RT (%) | 1.4 |

Remove & Replace Curb Ramp With Two New Directional Ramps or Equivalent.
