# Access Compliance Report Public Rights-of-Way (Curb Ramps)

| Main Street: ASCENSO_AVE | | Cross Street: SENDERO_WAY | | Location: | S |
| ADA ID: RPRK211117152703 | Ramp Type:Type 1 - Perpendicular | Initial Pass/Fail: Fail | Overall Compliance: No | Severity Score: | 15 |

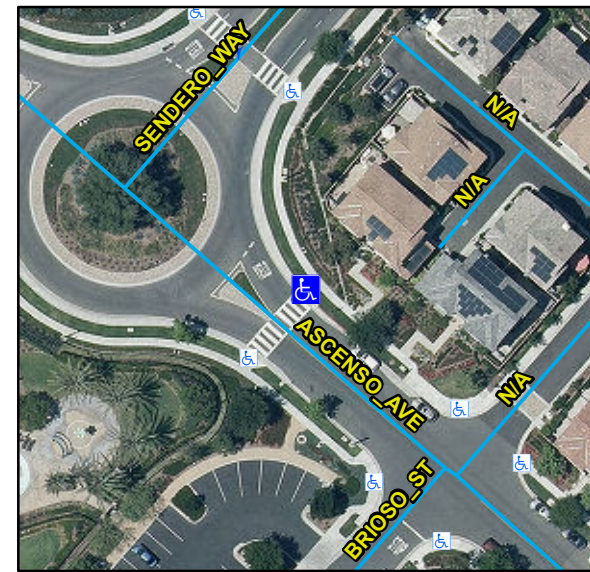
R304.2.2, R204.3, STD 1115

| Compliance | Description | Data | Compliance | Description | Data |
|---|---|---|---|---|---|
| No | Ramp Run Slope (%) | 9.5 | N/A | Flare Slope LT (%) | N/A |

Remove & Replace Entire Ramp.

Total Cost: \$ 3080
