# Access Compliance Report Public Rights-of-Way (Curb Ramps)

| Main Street: SENDERO WAY | | Cross Street: ASCENSO_AVE | | Location: | E |
| ADA ID: RPRK211117153248 | Ramp Type:Type 1 - Perpendicular | Initial Pass/Fail: Fail | Overall Compliance: No | Severity Score: | 16 |

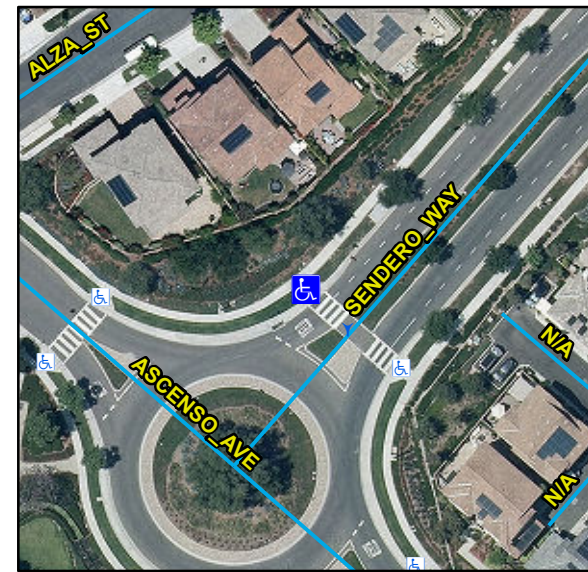
R204.3, R304.2.2, R304.5.3, STD 1115

| Compliance | Description | Data | Compliance | Description | Data |
|---|---|---|---|---|---|
| No | Ramp Run Slope (%) | 9.8 | N/A | Flare Slope LT (%) | N/A |
| No | Ramp Cross Slope (%) | 2.2 | N/A | Flare Traversable LT | N/A |

Remove & Replace Entire Ramp.
