# Access Compliance Report Public Rights-of-Way (Curb Ramps)

Main Street: ASCENSO\_AVE Cross Street: SENDERO\_WAY Location: N

ADA ID: RPRK211117153405 Ramp Type: Type 1 - Perpendicular Initial Pass/Fail: Fail Overall Compliance: No Severity Score: 15

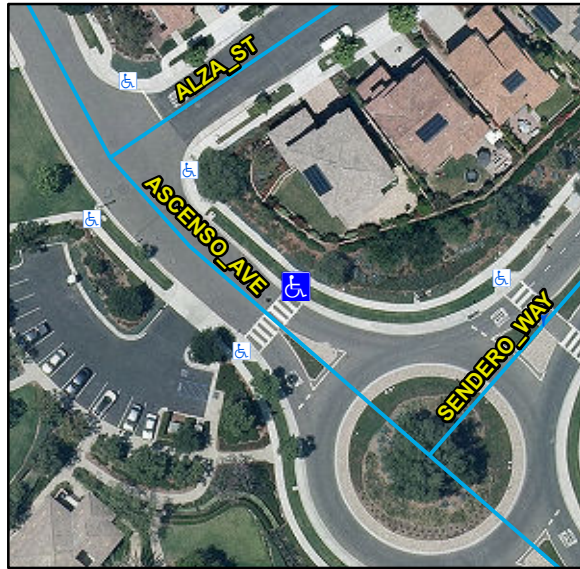
R204.3, R304.2.2, STD 1115

| Compliance | Description | Data | Compliance | Description | Data |
|---|---|---|---|---|---|
| No | Ramp Run Slope (%) | 8.7 | N/A | Flare Slope LT (%) | N/A |

Remove & Replace Entire Ramp.
