# Access Compliance Report Public Rights-of-Way (Curb Ramps)

Main Street: ASCENSO\_AVE Cross Street: SENDERO\_WAY Location: N

ADA ID: RPRK211117153539 Ramp Type: Type 1 - Perpendicular Initial Pass/Fail: Pass Overall Compliance: No Severity Score: 0

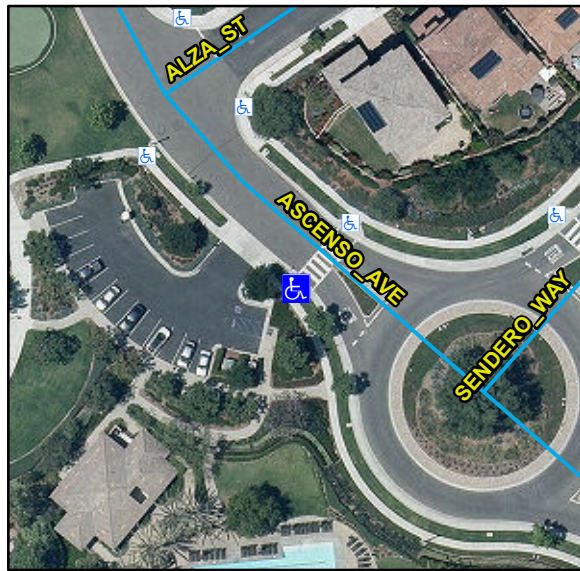
| Compliance | Description | Data | Compliance | Description | Data |
|---|---|---|---|---|---|
| Yes | Gutter Ponding | No | No | Curb Slope | 6.7 |
| No | Gutter Cross Slope (%) | 2.5 | | | |

Remove & Replace Curb Slope. Remove & Replace Gutter.

R304.2.2, R304.5.3, STD 1115
