# Access Compliance Report Public Rights-of-Way (Curb Ramps)

| Main Street: RIBERA_RD | | Cross Street: BRIOSO_ST | | Location: | SW |
| ADA ID: RPRK211118125254 | Ramp Type:Type 1 - Perpendicular | Initial Pass/Fail: Fail | Overall Compliance: No | Severity Score: | 15 |

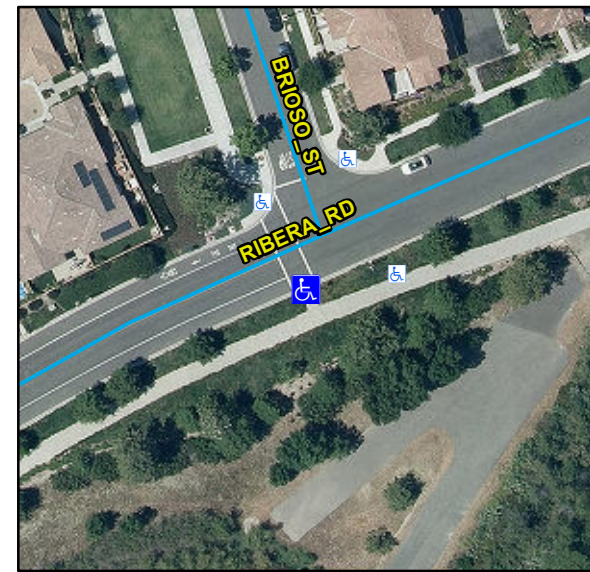
| Compliance | Description | Data | Compliance | Description | Data |
|---|---|---|---|---|---|
| No | Ramp Run Slope (%) | 9.2 | N/A | Flare Slope LT (%) | N/A |
| N/A | Gutter Ponding | N/A | No | Curb Slope | 8.3 |

Remove & Replace Entire Ramp.

R304.2.2, STD 1115
