# Access Compliance Report Public Rights-of-Way (Curb Ramps)

Main Street: LIGADO\_ST Cross Street: ESENCIA\_DR Location: S

ADA ID: RPRK211119115636 Ramp Type: Type 4 - Parallel Initial Pass/Fail: Fail Overall Compliance: No Severity Score: 16

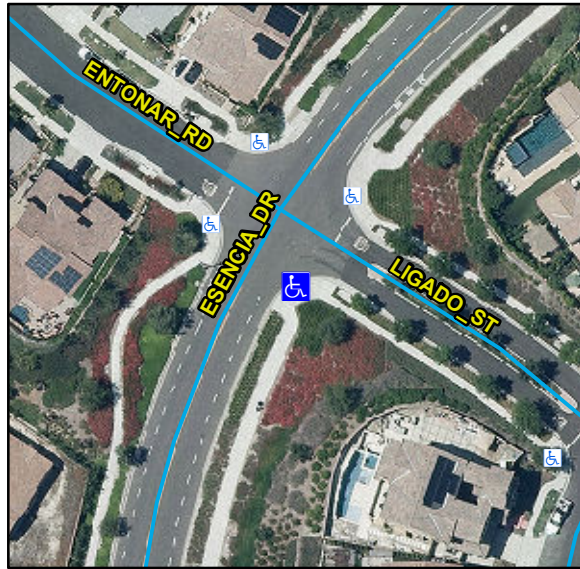
| Compliance | Description | Data | Compliance | Description | Data |
|---|---|---|---|---|---|
| No | Ramp Run Slope LT (%) | 11.9 | Yes | Ramp Run Slope RT (%) | 5.9 |
| No | Ramp Cross Slope LT (%) | 3.4 | No | Ramp Cross Slope RT (%) | 2.2 |

Remove & Replace Curb Ramp With Two New Directional Ramps or Equivalent.

R304.3.2, R304.5.3, STD 1115
