# Access Compliance Report Public Rights-of-Way (Curb Ramps)

| Main Street: ESENCIA_DR | | Cross Street: LIGADO_ST | | Location: | E |
| ADA ID: RPRK211119120131 | Ramp Type: Type 4 - Parallel | Initial Pass/Fail: Fail | Overall Compliance: No | Severity Score: | 15 |

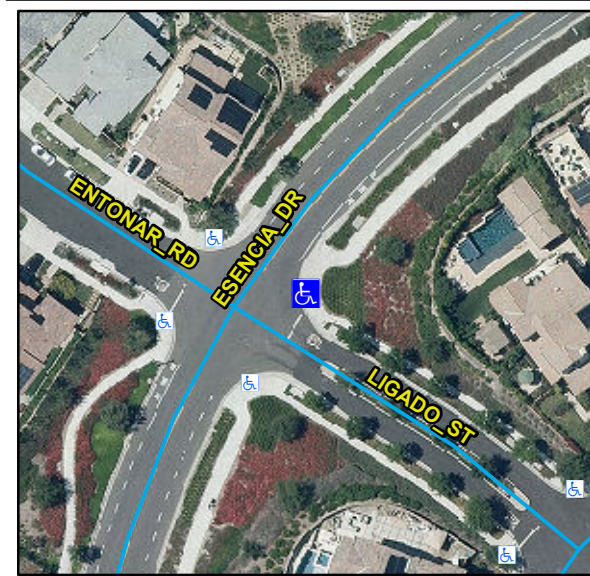
| Compliance | Description | Data | Compliance | Description | Data |
|---|---|---|---|---|---|
| No | Ramp Run Slope LT (%) | 10.1 | Yes | Ramp Run Slope RT (%) | 2.5 |

**Remove & Replace Curb Ramp With Two New Directional Ramps or Equivalent.**

**R304.3.2, STD 1115**
