# Access Compliance Report Public Rights-of-Way (Curb Ramps)

| Main Street: CADENCIA_ST | | Cross Street: LIGADO_ST | | Location: | W |
| ADA ID: RPRK211119120651 | Ramp Type: Type 4 - Parallel | Initial Pass/Fail: Fail | Overall Compliance: No | Severity Score: | 15 |

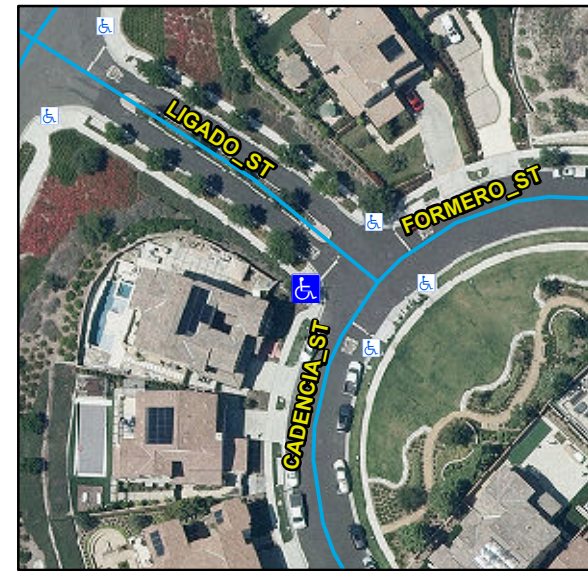
**R304.3.2, STD 1115**

| Compliance | Description | Data | Compliance | Description | Data |
|---|---|---|---|---|---|
| No | Ramp Run Slope LT (%) | 11.9 | Yes | Ramp Run Slope RT (%) | 2.6 |

**Remove & Replace Curb Ramp With Two New Directional Ramps or Equivalent.**
