# Access Compliance Report Public Rights-of-Way (Curb Ramps)

Main Street: FORMERO\_ST Cross Street: CADENCIA\_ST Location: SE

ADA ID: RPRK211119121600 Ramp Type: Type 1 - Perpendicular Initial Pass/Fail: Fail Overall Compliance: No Severity Score: 15

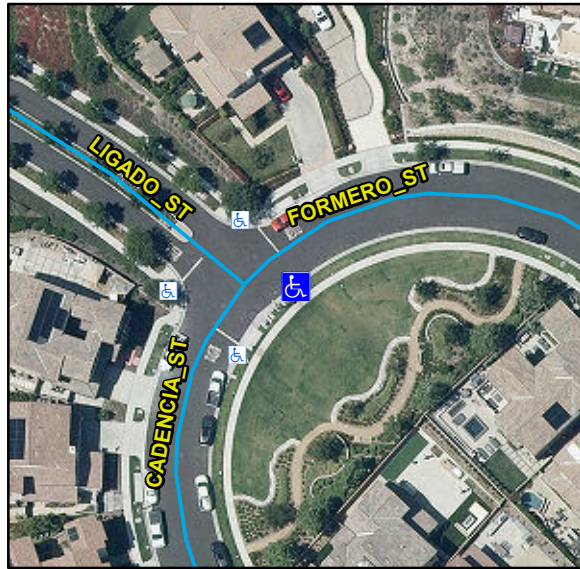
R304.2.2, STD 1115

| Compliance | Description | Data | Compliance | Description | Data |
|---|---|---|---|---|---|
| No | Ramp Run Slope (%) | 9.6 | N/A | Flare Slope LT (%) | N/A |

Remove & Replace Entire Ramp.
