# Access Compliance Report Public Rights-of-Way (Curb Ramps)

Main Street: VOLAR\_ST Cross Street: RISILLA\_ST Location: SE

ADA ID: RPRK211119133213 Ramp Type: Type 4 - Parallel Initial Pass/Fail: Fail Overall Compliance: No Severity Score: 19

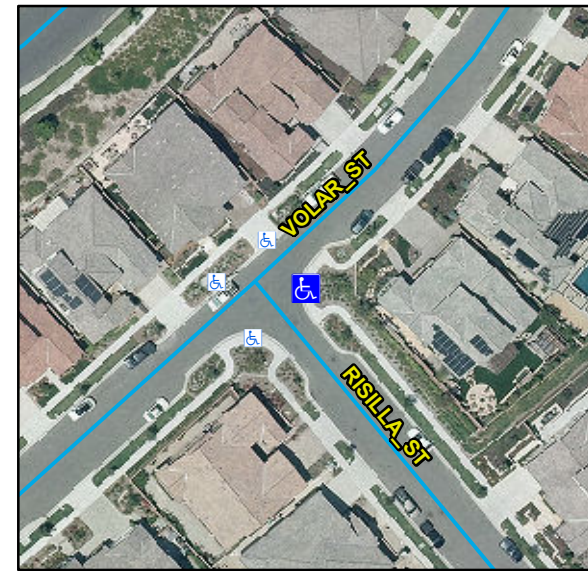
| Compliance | Description | Data | Compliance | Description | Data |
|---|---|---|---|---|---|
| No | Ramp Width LT (in) | 47 | No | Ramp Width RT (in) | 47 |
| No | Ramp Run Slope LT (%) | 9.3 | Yes | Ramp Run Slope RT (%) | 1.7 |

**Remove & Replace Curb Ramp With Two New Directional Ramps or Equivalent.**

**R304.5.1, R304.3.2, STD 1115**
