# Access Compliance Report Public Rights-of-Way (Curb Ramps)

Main Street: AIROSO\_ST Cross Street: CIMA\_DR Location: W

ADA ID: RPRK211119145736 Ramp Type: Type 1 - Perpendicular Diagonal Initial Pass/Fail: Fail Overall Compliance: No Severity Score: 2

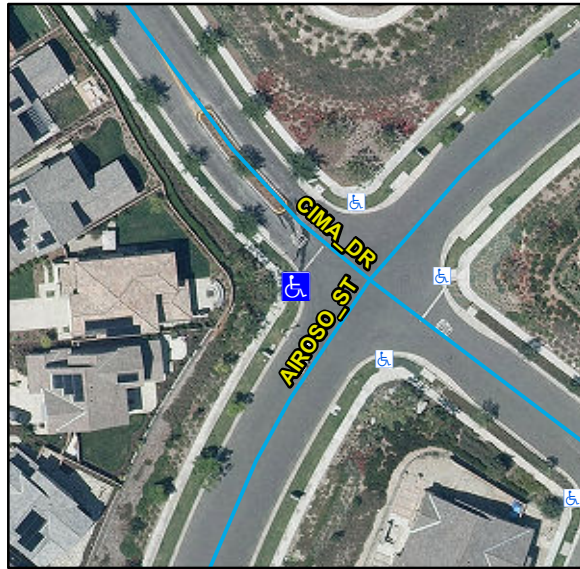
R304.2.2, R304.5.3, STD 1115

| Compliance | Description | Data | Compliance | Description | Data |
|---|---|---|---|---|---|
| No | Ramp Cross Slope (%) | 3.8 | N/A | Flare Traversable LT | N/A |

Remove & Replace Curb Ramp With Two New Directional Ramps or Equivalent.
