# Access Compliance Report Public Rights-of-Way (Curb Ramps)

| Main Street: N/A | | Cross Street: ORTEGA_HWY | | Location: | S |
| ADA ID: RPRK211122140627 | Ramp Type:Type 1 - Perpendicular | Initial Pass/Fail: Fail | Overall Compliance: No | Severity Score: | 2 |

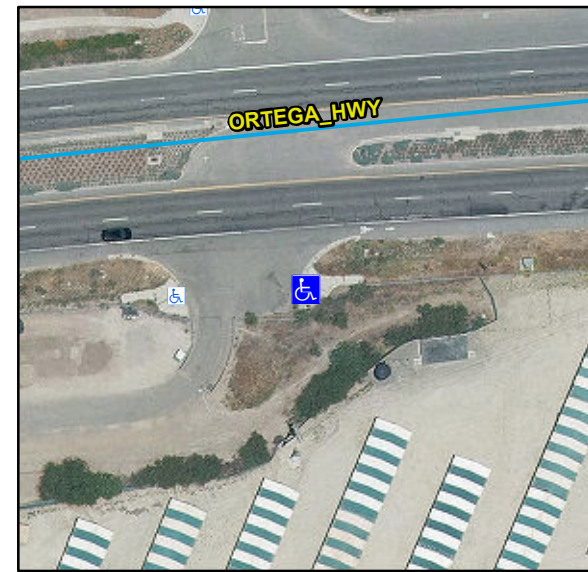
**R304.2.2, R304.5.3, STD 1115**

| Compliance | Description | Data | Compliance | Description | Data |
|---|---|---|---|---|---|
| No | Ramp Cross Slope (%) | 2.8 | N/A | Flare Traversable LT | N/A |

**Remove & Replace Entire Ramp.**

**\$ 3080**
