# Access Compliance Report Public Rights-of-Way (Curb Ramps)

Main Street: CHIQUITA\_CANYON\_DR Cross Street: AIROSO\_ST Location: N

ADA ID: RPRK211124130814 Ramp Type: Type 1 - Perpendicular Initial Pass/Fail: Fail Overall Compliance: No Severity Score: 0

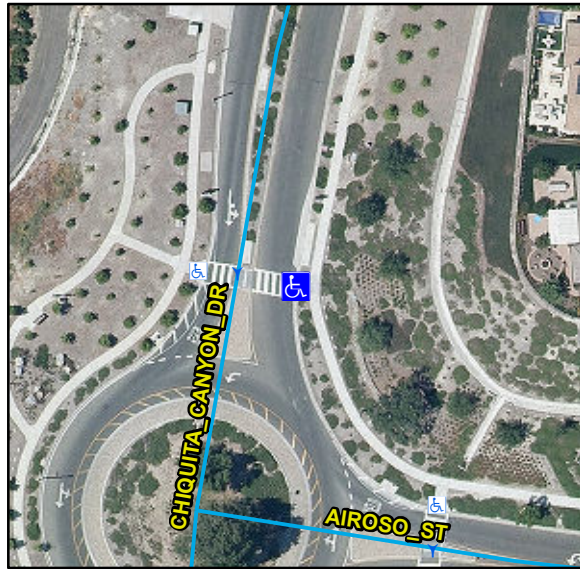
| Compliance | Description | Data | Compliance | Description | Data |
|---|---|---|---|---|---|
| N/A | Gutter Ponding | N/A | No | Curb Slope | 8.2 |

Remove & Replace Entire Ramp.

R304.2.2, STD 1115
