# Access Compliance Report Public Rights-of-Way (Curb Ramps)

Main Street: ESENCIA\_DR Cross Street: CHIQUITA\_CANYON\_DR Location: N

ADA ID: RPRK211124133726 Ramp Type: Type 1 - Perpendicular Diagonal Initial Pass/Fail: Fail Overall Compliance: No Severity Score: 16

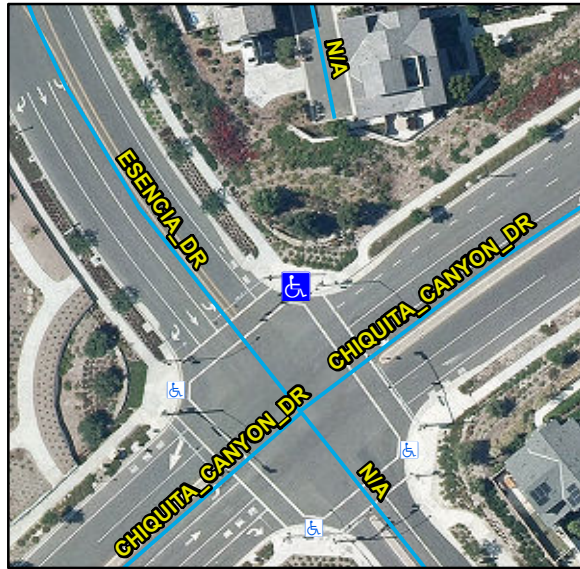
| Compliance | Description | Data | Compliance | Description | Data |
|---|---|---|---|---|---|
| No | Ramp Run Slope (%) | 9.5 | N/A | Flare Slope LT (%) | N/A |
| No | Ramp Cross Slope (%) | 2.6 | N/A | Flare Traversable LT | N/A |

Remove & Replace Curb Ramp With Two New Directional Ramps or Equivalent.
