# Access Compliance Report Public Rights-of-Way (Curb Ramps)

| Main Street: ESENCIA_DR | | Cross Street: SUERTE_ST | | Location: | N |
| ADA ID: RPRK211124140943 | Ramp Type: Type 1 - Perpendicular | Initial Pass/Fail: Fail | Overall Compliance: No | Severity Score: | 2 |

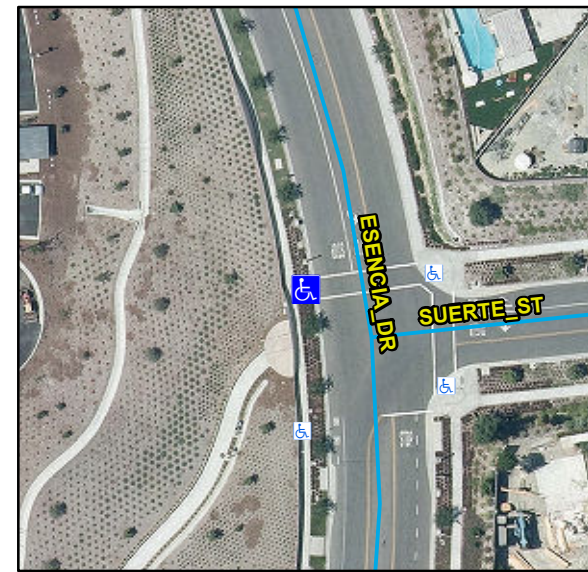
| Compliance | Description | Data | Compliance | Description | Data |
|---|---|---|---|---|---|
| No | Ramp Cross Slope (%) | 2.1 | N/A | Flare Traversable LT | N/A |

**Remove & Replace Entire Ramp.**

**R304.5.3, STD 1115**

Total Cost: \$ 3080
