# Access Compliance Report Public Rights-of-Way (Curb Ramps)

Main Street: JARANO\_ST Cross Street: OCASO\_ST Location: N

ADA ID: RPRK211124141845 Ramp Type: Type 1 - Perpendicular Initial Pass/Fail: Fail Overall Compliance: No Severity Score: 15

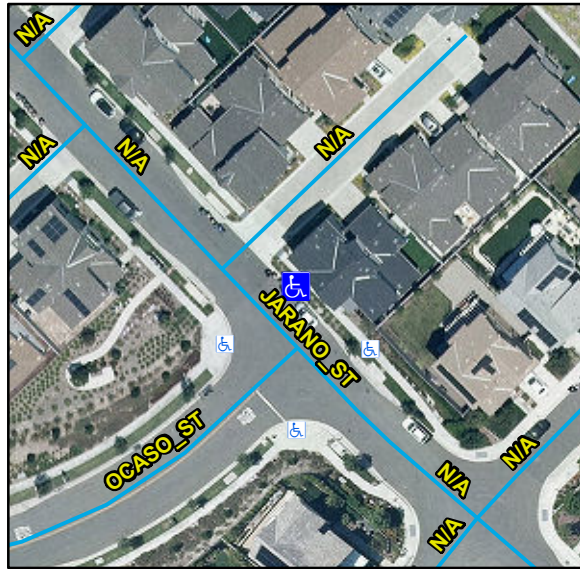
| Compliance | Description | Data | Compliance | Description | Data |
|---|---|---|---|---|---|
| No | Ramp Run Slope (%) | 10.7 | N/A | Flare Slope LT (%) | N/A |
| N/A | Gutter Ponding | N/A | No | Curb Slope | 11.5 |

Remove & Replace Entire Ramp.

R304.2.2, STD 1115
