# Access Compliance Report Public Rights-of-Way (Curb Ramps)

Main Street: OCASO\_ST Cross Street: AIROSO\_ST Location: SE

ADA ID: RPRK211124143121 Ramp Type: Type 1 - Perpendicular Diagonal Initial Pass/Fail: Fail Overall Compliance: No Severity Score: 16

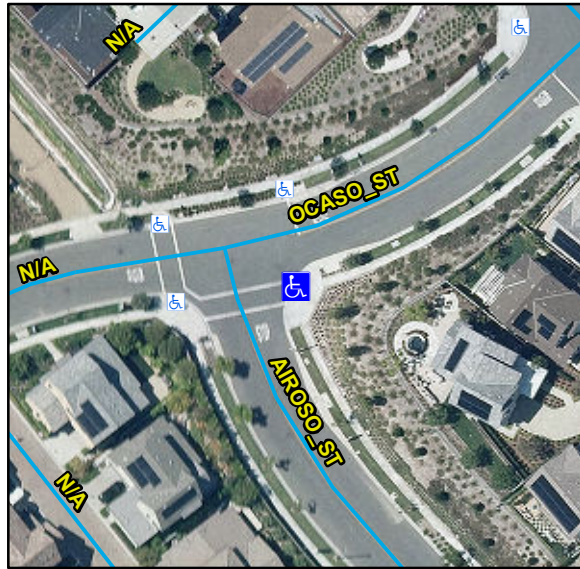
| Compliance | Description | Data | Compliance | Description | Data |
|---|---|---|---|---|---|
| No | Ramp Run Slope (%) | 9.2 | N/A | Flare Slope LT (%) | N/A |
| No | Ramp Cross Slope (%) | 3.1 | N/A | Flare Traversable LT | N/A |

Remove & Replace Curb Ramp With Two New Directional Ramps or Equivalent.
