# Access Compliance Report Public Rights-of-Way (Curb Ramps)

| Main Street: OCASO_ST | | Cross Street: AIROSO_ST | | Location: | N |
| ADA ID: RPRK211124143453 | Ramp Type: Type 1 - Perpendicular | Initial Pass/Fail: Fail | Overall Compliance: No | Severity Score: | 2 |

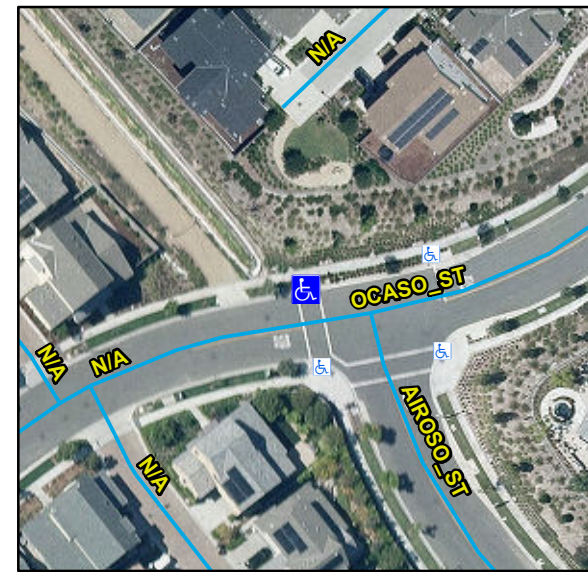
| Compliance | Description | Data | Compliance | Description | Data |
|---|---|---|---|---|---|
| No | Ramp Cross Slope (%) | 2.7 | N/A | Flare Traversable LT | N/A |
| N/A | Gutter Ponding | N/A | No | Curb Slope | 6.8 |

Possible Solutions:

Remove & Replace Entire Ramp.
