# Access Compliance Report Public Rights-of-Way (Curb Ramps)

Main Street: ESENCIA\_DR Cross Street: COW\_CAMP\_RD Location: E

ADA ID: RPRK211129121216 Ramp Type: Type 1 - Perpendicular Diagonal Initial Pass/Fail: Fail Overall Compliance: No Severity Score: 16

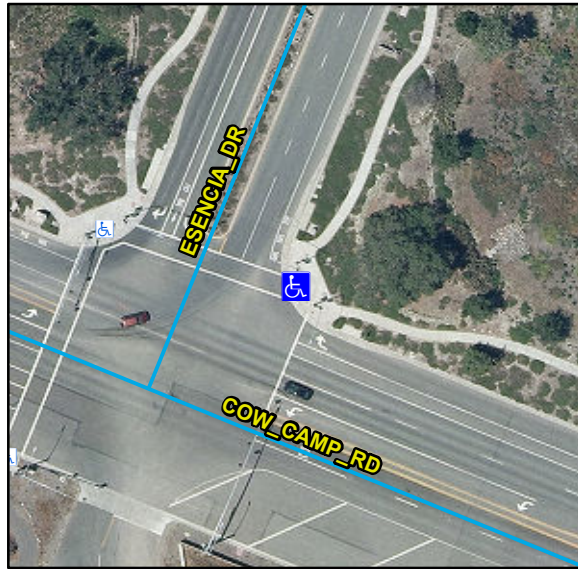
| Compliance | Description | Data | Compliance | Description | Data |
|---|---|---|---|---|---|
| No | Ramp Run Slope (%) | 8.5 | N/A | Flare Slope LT (%) | N/A |

Remove & Replace Curb Ramp With Two New Directional Ramps or Equivalent.

R304.2.2, STD 1115
