# Access Compliance Report Public Rights-of-Way (Curb Ramps)

Main Street: ESENCIA\_DR Cross Street: ANDAZA\_ST Location: NW

ADA ID: RPRK211129123014 Ramp Type: Type 1 - Perpendicular Initial Pass/Fail: Pass Overall Compliance: No Severity Score: 6

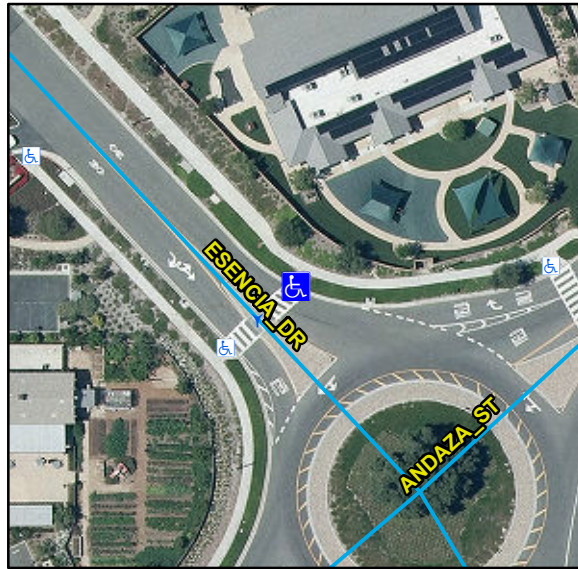
| Compliance | Description | Data | Compliance | Description | Data |
|---|---|---|---|---|---|
| Yes | Gutter Ponding | No | No | Curb Slope | 8.2 |
| No | Gutter Run Slope (%) | 5.9 | | Road Cross Slope (%) | N/A |

Remove & Replace Curb Slope. Remove & Replace Gutter.
