# Access Compliance Report Public Rights-of-Way (Curb Ramps)

Main Street: ANDAZA\_ST Cross Street: ESENCIA\_DR Location: SW

ADA ID: RPRK211129123723 Ramp Type: Type 1 - Perpendicular Initial Pass/Fail: Fail Overall Compliance: No Severity Score: 2

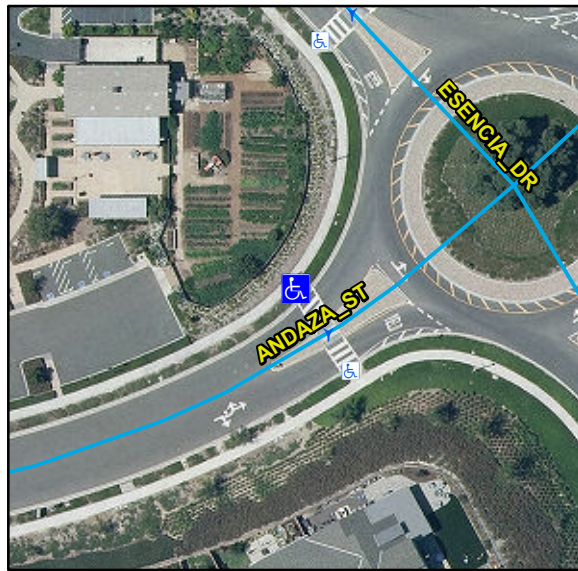
R304.2.2, R304.5.3, STD 1115

| Compliance | Description | Data | Compliance | Description | Data |
|---|---|---|---|---|---|
| No | Ramp Cross Slope (%) | 2.4 | N/A | Flare Traversable LT | N/A |

Remove & Replace Entire Ramp.
