# Access Compliance Report Public Rights-of-Way (Curb Ramps)

| Main Street: ESENCIA_DR | | Cross Street: ANDAZA_ST | | Location: | S |
| ADA ID: RPRK211129124314 | Ramp Type:Type 1 - Perpendicular | Initial Pass/Fail: Fail | Overall Compliance: No | Severity Score: | 2 |

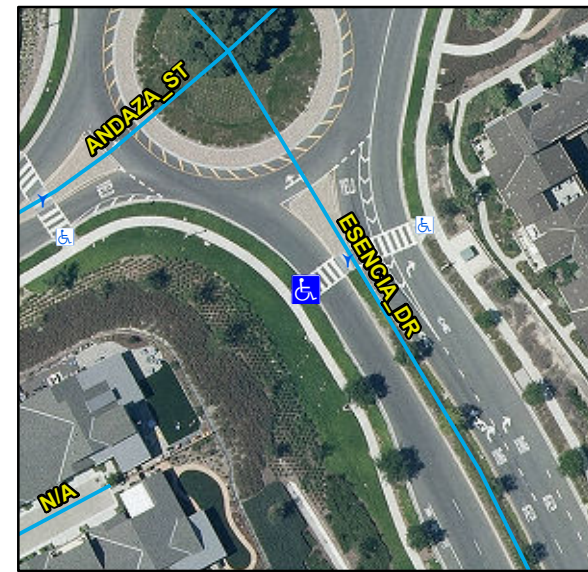
| Compliance | Description | Data | Compliance | Description | Data |
|---|---|---|---|---|---|
| No | Ramp Cross Slope (%) | 2.6 | N/A | Flare Traversable LT | N/A |

Remove & Replace Entire Ramp.

R304.5.3, STD 1115
