# Access Compliance Report Public Rights-of-Way (Curb Ramps)

Main Street: **ANDAZA\_ST** Cross Street: **TIERNO\_RD** Location: **W**

ADA ID: **RPRK211129124958** Ramp Type: **Type 1 - Perpendicular** Initial Pass/Fail: **Pass** Overall Compliance: **Yes** Severity Score: **0**

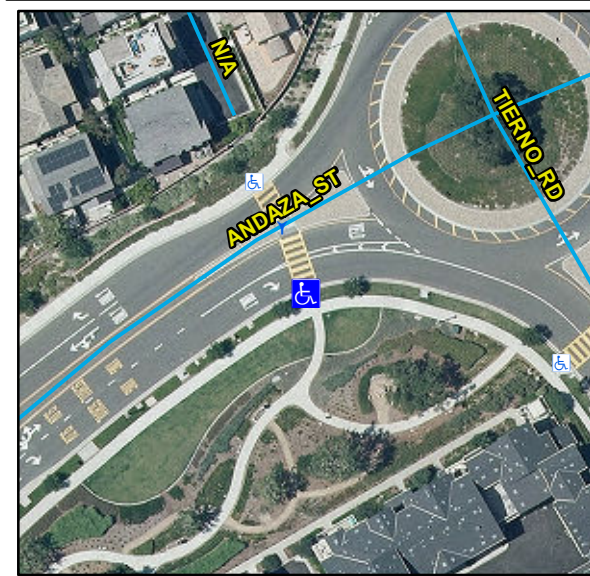
| Compliance | Description | Data | Compliance | Description | Data |
|---|---|---|---|---|---|
| Yes | Overall Surface Condition: <b>Acceptable</b> | | Yes | Perp Joint Present | Yes |

Possible Solutions:  
**N/A**
