# Access Compliance Report Public Rights-of-Way (Curb Ramps)

Main Street: TIERNO\_RD Cross Street: ANDAZA\_ST Location: S

ADA ID: RPRK211129131810 Ramp Type: Type 1 - Perpendicular Initial Pass/Fail: Fail Overall Compliance: No Severity Score: 30

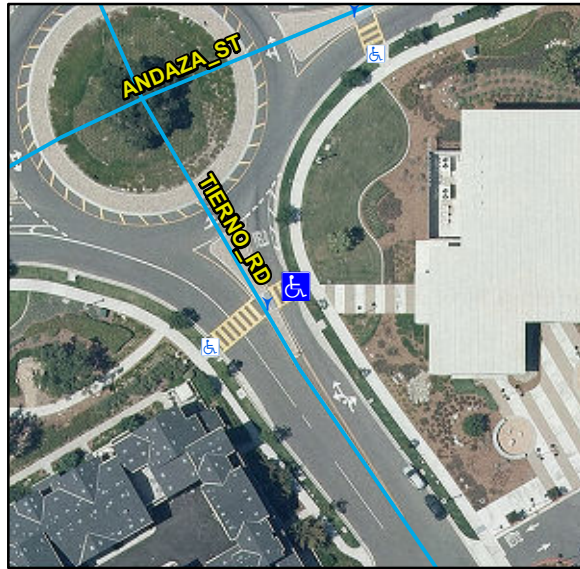
| Compliance | Description | Data | Compliance | Description | Data |
|---|---|---|---|---|---|
| No | Ramp Run Slope (%) | 13.8 | N/A | Flare Slope LT (%) | N/A |

Remove & Replace Entire Ramp.

R304.2.2, STD 1115
