# Access Compliance Report Public Rights-of-Way (Curb Ramps)

| Main Street: ANDAZA_ST | | Cross Street: TIERNO_RD | | Location: | E |
| ADA ID: RPRK211129131922 | Ramp Type:Type 1 - Perpendicular | Initial Pass/Fail: Fail | Overall Compliance: No | Severity Score: | 30 |

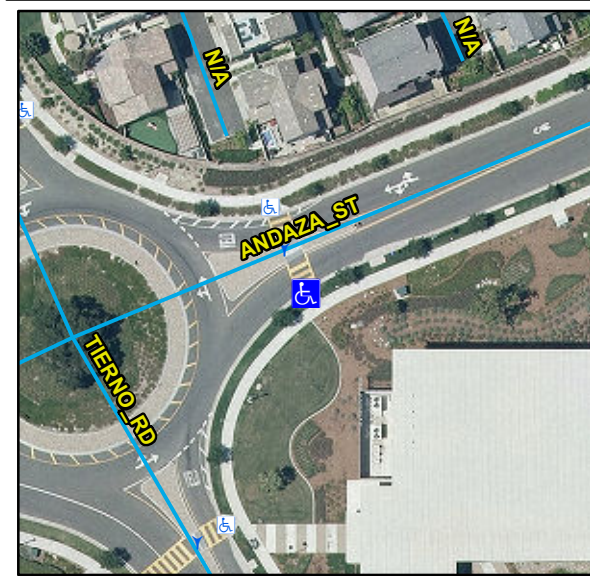
| Compliance | Description | Data | Compliance | Description | Data |
|---|---|---|---|---|---|
| No | Ramp Run Slope (%) | 14.3 | N/A | Flare Slope LT (%) | N/A |

Remove & Replace Entire Ramp.

R304.2.2, STD 1115
