# Access Compliance Report Public Rights-of-Way (Curb Ramps)

Main Street: VENTADA\_ST Cross Street: BALIZA\_RD Location: W

ADA ID: RPRK211129134507 Ramp Type: Type 4 - Parallel Initial Pass/Fail: Fail Overall Compliance: No Severity Score: 2

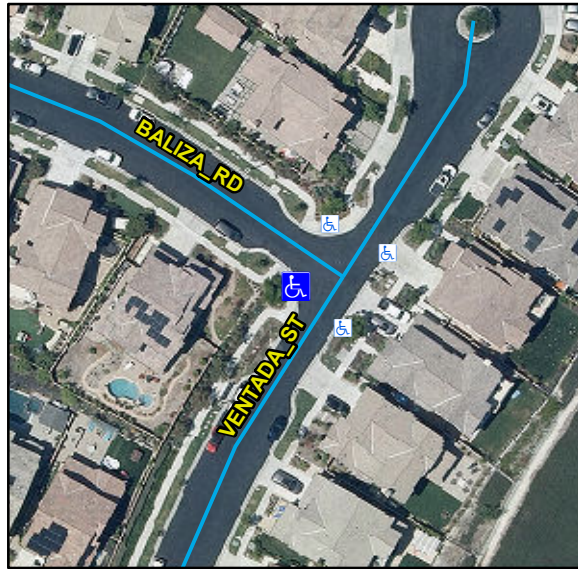
| Compliance | Description | Data | Compliance | Description | Data |
|---|---|---|---|---|---|
| No | Ramp Cross Slope LT (%) | 2.2 | Yes | Ramp Cross Slope RT (%) | 0 |

Remove & Replace Curb Ramp With Two New Directional Ramps or Equivalent.

R304.5.3, STD 1115
