# Access Compliance Report Public Rights-of-Way (Curb Ramps)

Main Street: CERRERO\_CT Cross Street: SALIENTE\_RD Location: NW

ADA ID: RPRK211129141324 Ramp Type: Type 1 - Perpendicular Initial Pass/Fail: Fail Overall Compliance: No Severity Score: 32

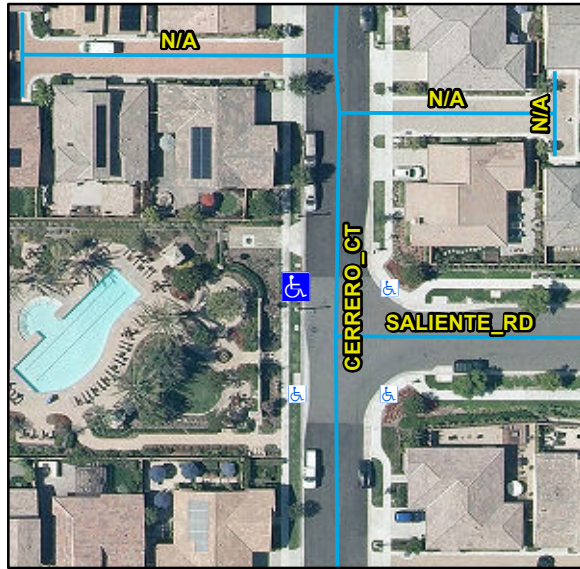
| Compliance | Description | Data | Compliance | Description | Data |
|---|---|---|---|---|---|
| No | Ramp Run Slope (%) | 17.3 | N/A | Flare Slope LT (%) | N/A |
| No | Gutter Lip Height (in) | 0.25 | | Road Run Slope (%) | N/A |

Remove & Replace Entire Ramp.
