# Access Compliance Report Public Rights-of-Way (Curb Ramps)

Main Street: AIROSO\_ST Cross Street: ESENCIA\_DR Location: SE

ADA ID: RPRK211129142424 Ramp Type: Type 1 - Perpendicular Initial Pass/Fail: Fail Overall Compliance: No Severity Score: 16

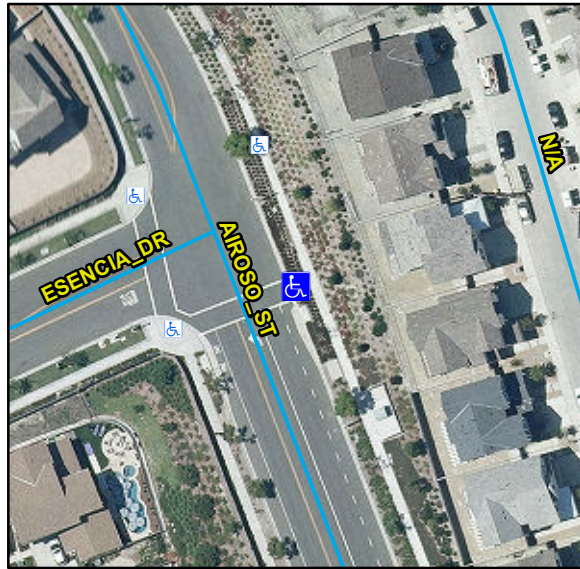
R304.2.2, R304.5.3, STD 1115

| Compliance | Description | Data | Compliance | Description | Data |
|---|---|---|---|---|---|
| No | Ramp Run Slope (%) | 8.5 | N/A | Flare Slope LT (%) | N/A |
| No | Ramp Cross Slope (%) | 2.6 | N/A | Flare Traversable LT | N/A |

Remove & Replace Entire Ramp.
