# Access Compliance Report Public Rights-of-Way (Curb Ramps)

| Main Street: N/A | | Cross Street: ESENCIA_DR | | Location: | SW |
| ADA ID: RPRK211129143138 | Ramp Type: Type 1 - Perpendicular | Initial Pass/Fail: Fail | Overall Compliance: No | Severity Score: | 2 |

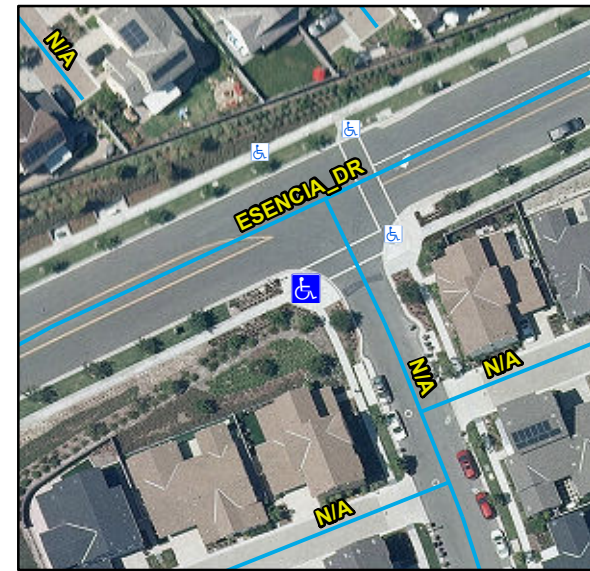
R304.2.2, R304.5.3, STD 1115

| Compliance | Description | Data | Compliance | Description | Data |
|---|---|---|---|---|---|
| No | Ramp Cross Slope (%) | 2.5 | N/A | Flare Traversable LT | N/A |

Remove & Replace Entire Ramp.

\$ 3080
