# Access Compliance Report Public Rights-of-Way (Curb Ramps)

Main Street: ESENCIA\_DR Cross Street: N/A Location: N

ADA ID: RPRK211129143523 Ramp Type: Type 1 - Perpendicular Initial Pass/Fail: Fail Overall Compliance: No Severity Score: 2

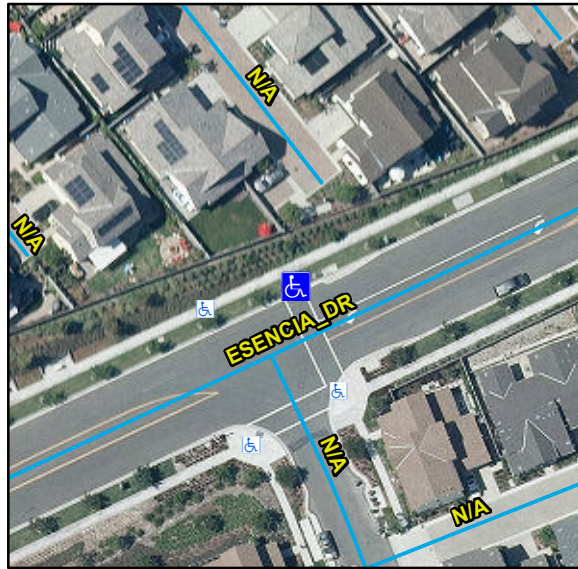
R304.2.2, R304.5.3, STD 1115

| Compliance | Description | Data | Compliance | Description | Data |
|---|---|---|---|---|---|
| No | Ramp Cross Slope (%) | 3.2 | N/A | Flare Traversable LT | N/A |

Remove & Replace Entire Ramp.
