# Access Compliance Report Public Rights-of-Way (Curb Ramps)

Main Street: ESENCIA\_DR Cross Street: MEDANO\_ST Location: SE

ADA ID: RPRK211130131619 Ramp Type: Type 1 - Perpendicular Diagonal Initial Pass/Fail: Fail Overall Compliance: No Severity Score: 2

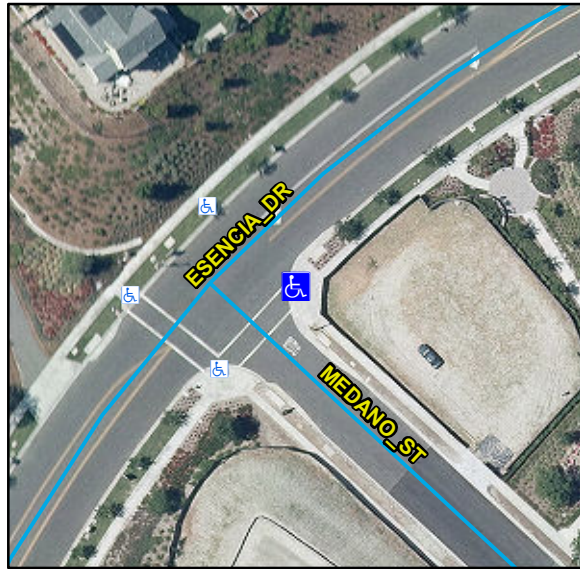
| Compliance | Description | Data | Compliance | Description | Data |
|---|---|---|---|---|---|
| No | Ramp Cross Slope (%) | 2.1 | N/A | Flare Traversable LT | N/A |

**Remove & Replace Curb Ramp With Two New Directional Ramps or Equivalent.**

**R304.5.3, STD 1115**
