# Access Compliance Report Public Rights-of-Way (Curb Ramps)

Main Street: MEDANO\_ST Cross Street: ESENCIA\_DR Location: SW

ADA ID: RPRK211130132221 Ramp Type: Type 1 - Perpendicular Diagonal Initial Pass/Fail: Fail Overall Compliance: No Severity Score: 16

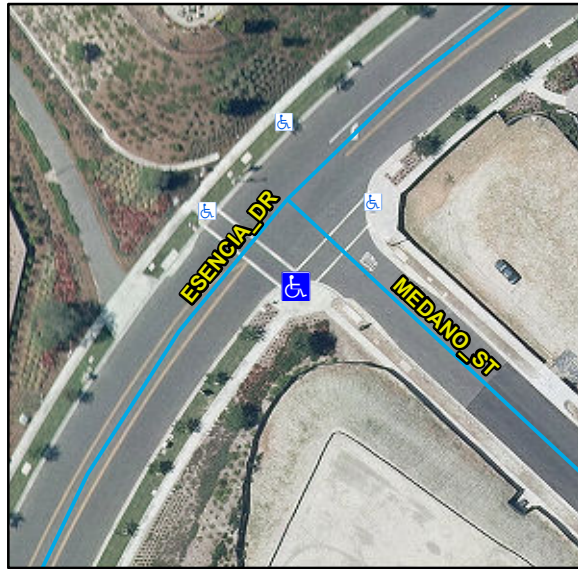
| Compliance | Description | Data | Compliance | Description | Data |
|---|---|---|---|---|---|
| No | Ramp Run Slope (%) | 9.8 | N/A | Flare Slope LT (%) | N/A |
| No | Ramp Cross Slope (%) | 2.4 | N/A | Flare Traversable LT | N/A |

Remove & Replace Curb Ramp With Two New Directional Ramps or Equivalent.
