# Access Compliance Report Public Rights-of-Way (Curb Ramps)

| Main Street: ESENCIA_DR | | Cross Street: FAUNA_DR | | Location: | N |
| ADA ID: RPRK211201123903 | Ramp Type:Type 1 - Perpendicular | Initial Pass/Fail: Fail | Overall Compliance: No | Severity Score: | 2 |

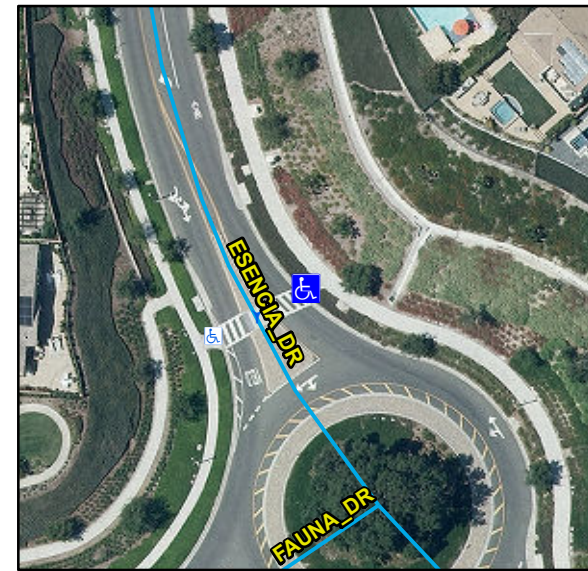
**R304.2.2, R304.5.3, STD 1115**

| Compliance | Description | Data | Compliance | Description | Data |
|---|---|---|---|---|---|
| No | Ramp Cross Slope (%) | 4.1 | N/A | Flare Traversable LT | N/A |

**Remove & Replace Entire Ramp.**
