# Access Compliance Report Public Rights-of-Way (Curb Ramps)

| Main Street: ESENCIA_DR | | Cross Street: FAUNA_DR | | Location: | N |
| ADA ID: RPRK211201124312 | Ramp Type:Type 1 - Perpendicular | Initial Pass/Fail: Fail | Overall Compliance: No | Severity Score: | 16 |

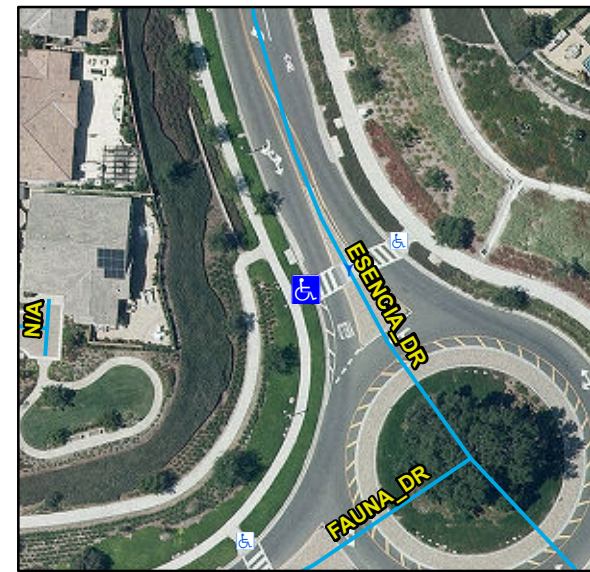
R304.2.2, R304.5.3, STD 1115

| Compliance | Description | Data | Compliance | Description | Data |
|---|---|---|---|---|---|
| No | Ramp Run Slope (%) | 8.4 | N/A | Flare Slope LT (%) | N/A |
| No | Ramp Cross Slope (%) | 4.5 | N/A | Flare Traversable LT | N/A |

Remove & Replace Entire Ramp.
