# Access Compliance Report Public Rights-of-Way (Curb Ramps)

Main Street: FAUNA\_DR Cross Street: ESENCIA\_DR Location: W

ADA ID: RPRK211201124520 Ramp Type: Type 1 - Perpendicular Initial Pass/Fail: Fail Overall Compliance: No Severity Score: 2

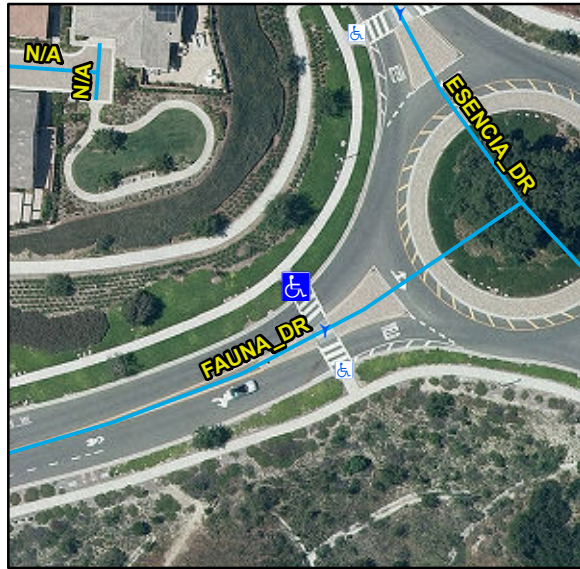
| Compliance | Description | Data | Compliance | Description | Data |
|---|---|---|---|---|---|
| No | Ramp Cross Slope (%) | 2.7 | N/A | Flare Traversable LT | N/A |

Remove & Replace Entire Ramp.

R304.5.3, STD 1115
