# Access Compliance Report Public Rights-of-Way (Curb Ramps)

| Main Street: ESENCIA_DR | | Cross Street: FAUNA_DR | | Location: | S |
| ADA ID: RPRK211201125450 | Ramp Type:Type 1 - Perpendicular | Initial Pass/Fail: Pass | Overall Compliance: No | Severity Score: | 5 |

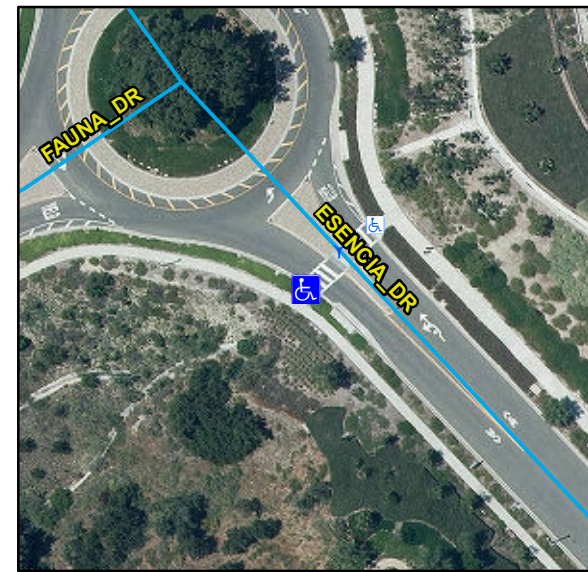
R304.2.2, R304.2.2-Perp, R304.3.2-Para, STD 1115

| Compliance | Description | Data | Compliance | Description | Data |
|---|---|---|---|---|---|
| No | Landing Run Slope (%) | 8.3 | N/A | Flare Traversable RT | No |
| Yes | Gutter Ponding | No | No | Curb Slope | 5.7 |

Remove & Replace Entire Ramp.

Total Cost: \$ 3080
