# Access Compliance Report Public Rights-of-Way (Curb Ramps)

Main Street: ESENCIA\_DR Cross Street: FAUNA\_DR Location: S

ADA ID: RPRK211201130006 Ramp Type: Type 1 - Perpendicular Initial Pass/Fail: Fail Overall Compliance: No Severity Score: 2

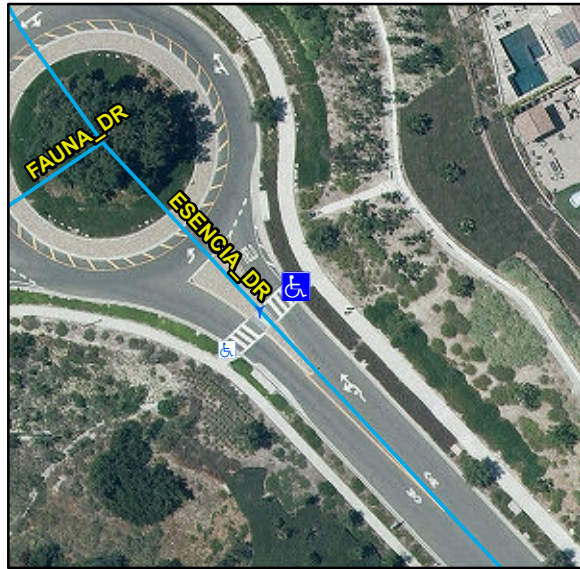
R304.2.2, R304.5.3, STD 1115

| Compliance | Description | Data | Compliance | Description | Data |
|---|---|---|---|---|---|
| No | Ramp Cross Slope (%) | 2.3 | N/A | Flare Traversable LT | N/A |
| N/A | Gutter Ponding | N/A | No | Curb Slope | 9.5 |

Remove & Replace Entire Ramp.
