# Access Compliance Report Public Rights-of-Way (Curb Ramps)

Main Street: PUESTO\_DR Cross Street: BARACA\_DR Location: NE

ADA ID: RPRK211201142654 Ramp Type: Type 1 - Perpendicular Diagonal Initial Pass/Fail: Pass Overall Compliance: No Severity Score: 6

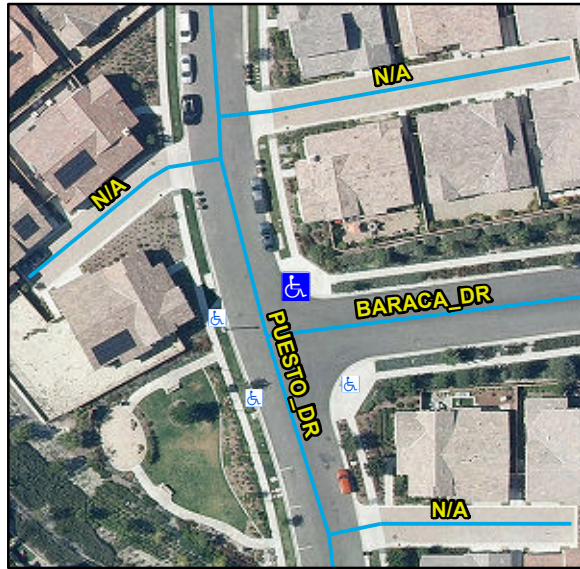
R304.5.4, R304.5.3, STD 1115

| Compliance | Description | Data | Compliance | Description | Data |
|---|---|---|---|---|---|
| No | Gutter Run Slope (%) | 7.4 | | Road Cross Slope (%) | 3.9 |
| No | Gutter Cross Slope (%) | 4.2 | | | |

Remove & Replace Gutter.
