# Access Compliance Report Public Rights-of-Way (Curb Ramps)

Main Street: AIROSO\_ST Cross Street: ANDAZA\_ST Location: W

ADA ID: RPRK211203115225 Ramp Type: Type 1 - Perpendicular Initial Pass/Fail: Fail Overall Compliance: No Severity Score: 16

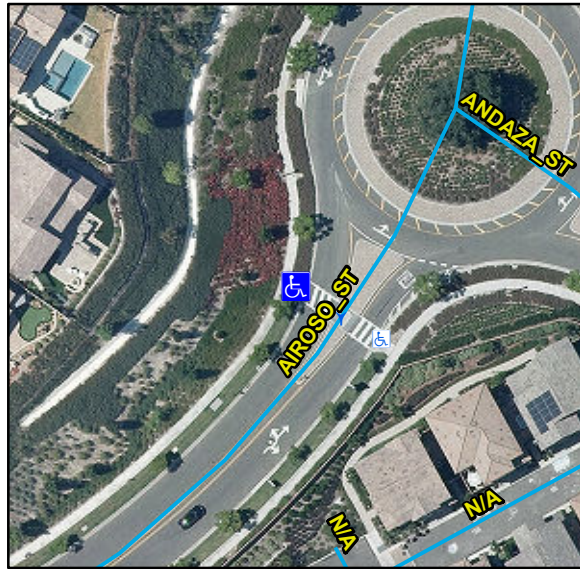
R304.2.2, R304.5.3, STD 1115

| Compliance | Description | Data | Compliance | Description | Data |
|---|---|---|---|---|---|
| No | Ramp Run Slope (%) | 8.4 | N/A | Flare Slope LT (%) | N/A |
| No | Ramp Cross Slope (%) | 2.6 | N/A | Flare Traversable LT | N/A |

Remove & Replace Entire Ramp.
