# Access Compliance Report Public Rights-of-Way (Curb Ramps)

| Main Street: CHRISTY_LN | | Cross Street: COPA_DE_ORO_DR | | Location: | SW |
| ADA ID: RPRK211207133233 | Ramp Type:Type 1 - Perpendicular Diagonal Initial Pass/Fail: Fail | | Overall Compliance: No | Severity Score: | 2 |

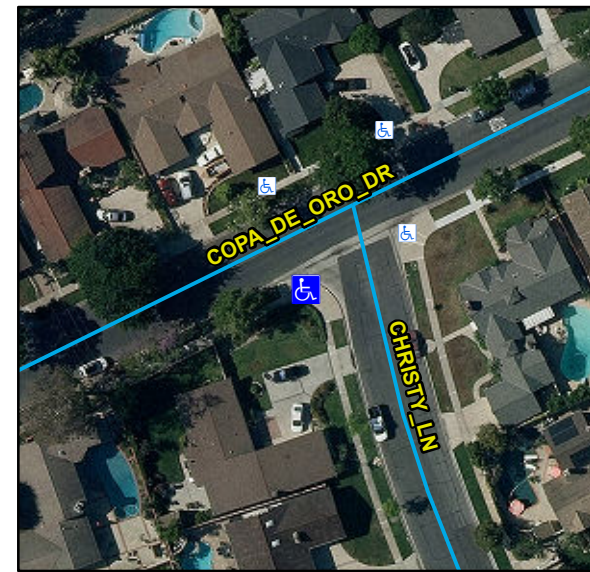
| Compliance | Description | Data | Compliance | Description | Data |
|---|---|---|---|---|---|
| No | Ramp Cross Slope (%) | 4.8 | N/A | Flare Traversable LT | N/A |
| No | Gutter Lip Height (in) | 0.5 | | Road Run Slope (%) | 2.9 |

**Remove & Replace Curb Ramp With Two New Directional Ramps or Equivalent. Grind Gutter Lip.**
