# Access Compliance Report Public Rights-of-Way (Curb Ramps)

Main Street: COPA\_DE\_ORO\_DR Cross Street: CHRISTY\_LN Location: SE

ADA ID: RPRK211207133541 Ramp Type: Type 1 - Perpendicular Diagonal Initial Pass/Fail: Fail Overall Compliance: No Severity Score: 0

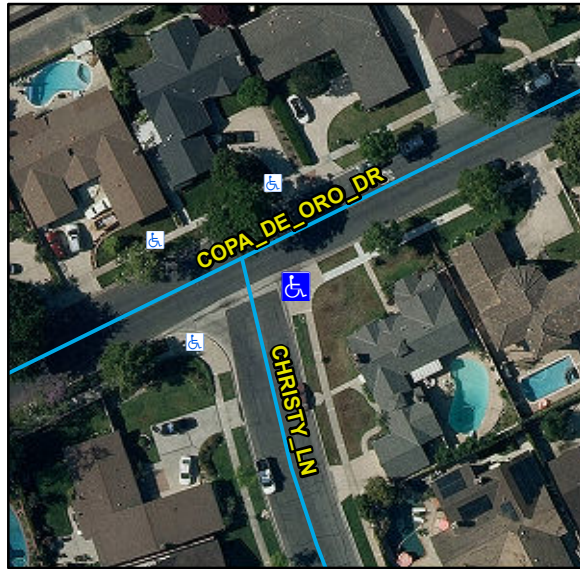
R304.2.2, R204.3, R302.7.2, STD 1115

| Compliance | Description | Data | Compliance | Description | Data |
|---|---|---|---|---|---|
| No | Gutter Lip Height (in) | 0.5 | | Road Run Slope (%) | 3.3 |

Remove & Replace Curb Ramp With Two New Directional Ramps or Equivalent.
