# Access Compliance Report Public Rights-of-Way (Curb Ramps)

| Main Street: BELLWOOD_RD | | Cross Street: COPA_DE_ORO_DR | | Location: | SW |
| ADA ID: RPRK211207134033 | Ramp Type:Type 1 - Perpendicular Diagonal Initial Pass/Fail: Fail | | Overall Compliance: No | Severity Score: | 2 |

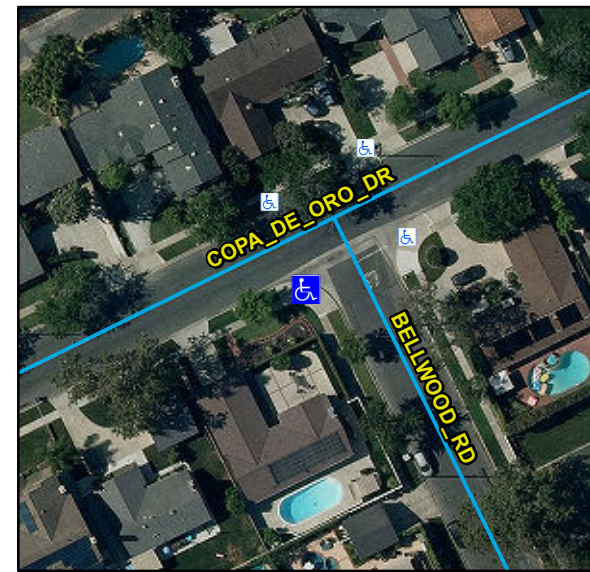
**R204.3, R304.5.3, STD 1115**

| Compliance | Description | Data | Compliance | Description | Data |
|---|---|---|---|---|---|
| No | Ramp Cross Slope (%) | 4.3 | N/A | Flare Traversable LT | N/A |

**Remove & Replace Curb Ramp With Two New Directional Ramps or Equivalent.**
