Access Compliance Report Public Rights-of-Way (Curb Ramps)

Main Street: **BRIMHALL_DR** Cross Street: **BELLWOOD_RD** Location: **NW**

ADA ID: **RPRK211207135904** Ramp Type: **Type 1 - Perpendicular Diagonal** Initial Pass/Fail: **Fail** Overall Compliance: **No** Severity Score: **2**

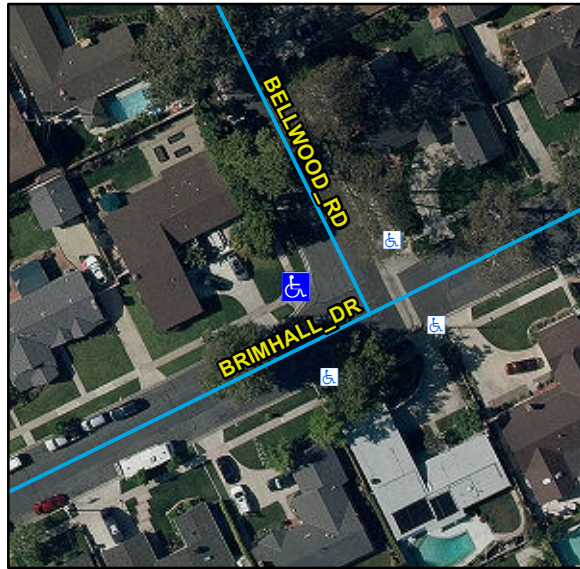
Compliance	Description	Data	Compliance	Description	Data
N/A	Ramp Length (in)	85	N/A	Flare Type LT	
Yes	Ramp Width (in)	48			N/A
Yes	Ramp Run Slope (%)	5.7	N/A	Flare Slope LT (%)	N/A
No	Ramp Cross Slope (%)	2.5	N/A	Flare Traversable LT	N/A
N/A	Landing Present	N/A	N/A	Flare Type RT	
N/A	Landing Length (in)	N/A			N/A
N/A	Landing Width (in)	N/A	N/A	Flare Slope RT (%)	N/A
N/A	Landing Run Slope (%)	N/A	N/A	Flare Traversable RT	N/A
N/A	Landing Cross Slope (%)	N/A	N/A	DWS Provided	N/A
N/A	Landing Movement Obstructed?	N/A	N/A	DWS Contrast	N/A
	Landing Movement Type	N/A	N/A	DWS Length (in)	N/A
N/A	Landing Shared	N/A	N/A	DWS Full Width	N/A
N/A	Clear Space	Yes	N/A	DWS Offset Left (in)	N/A
N/A	Clear Space To Crosswalk (in)	N/A	N/A	DWS Offset Right (in)	N/A
N/A	Marked Crosswalk 1	No	N/A	Marked Crosswalk 2	No
	Crossing 1 Direction	S		Crossing 2 Direction	E
	Marked Crosswalk 1 Width (in)	N/A		Marked Crosswalk 2 Width (in)	N/A

N/A	Ramp Inside Crosswalk 1	N/A	Yes	Ramp Inside Crosswalk 2	N/A
	Crossing 1 Slope (%)	9.9		Crossing 2 Slope (%)	2.6
	Crossing 1 Cross Slope (%)	2.3		Crossing 2 Cross Slope (%)	1
N/A	Gutter Ponding	N/A	N/A	Curb Slope	4.3
Yes	Gutter Lip Height (in)	0		Road Run Slope (%)	0.4
N/A	Gutter Run Slope (%)	N/A		Road Cross Slope (%)	5.9
N/A	Gutter Cross Slope (%)	N/A			
Yes	Overall Surface Condition: Acceptable		No	Perp Joint Present	No
	Cross Gutter Present?	No		Spandrel Present?	No
	Replace Cross Gutter?	N/A		Replace Spandrel?	N/A

Possible Solutions:
Remove & Replace Curb Ramp With Two New Directional Ramps or Equivalent.

OC Std/PROW:
R204.3, R304.5.3, STD 1115
